## CASE HISTORY:

### Historic Lighthouse on Hunting Island, South Carolina

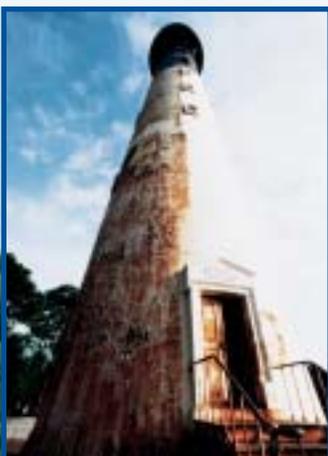
In 1981, a Rohm and Haas employee was vacationing on Hunting Island and noticed that the lighthouse was in bad disrepair. There were holes in the cast iron ranging in size from 1/4 to 2 inches in diameter. The alkyd coating that was applied seven years prior had deteriorated badly, embrittling and cracking, especially along the north side. Heavy rust spotting and run-down originating at the plate joints and the pitted areas had turned the once-attractive landmark into an eyesore. A complete restoration was planned.

Lighthouse in 1982 prior to restoration, showing heavy corrosion on northwest side

The first step in the 1982 restoration was to sandblast the cast iron plates back to bare metal. Thousands of holes were laboriously hand-filled using putty knives and an acrylic-modified cementitious compound which was designed to expand and contract with the metal. A red waterborne acrylic primer containing anti-corrosive pigments was applied to the clean steel, and followed by a white midcoat based on the same

acrylic resin. Then gloss waterborne acrylic topcoats were applied to match the historical color scheme – white on the bottom and black on top. The total dry film thickness was approximately 9 mils.

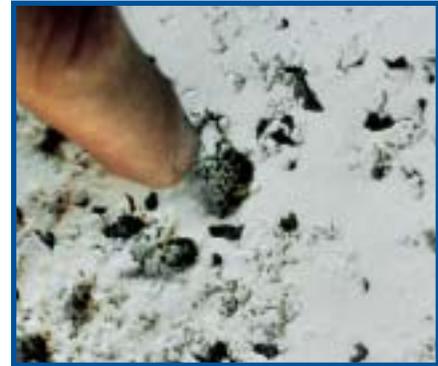
Close-up showing pits and holes in cast iron plates.

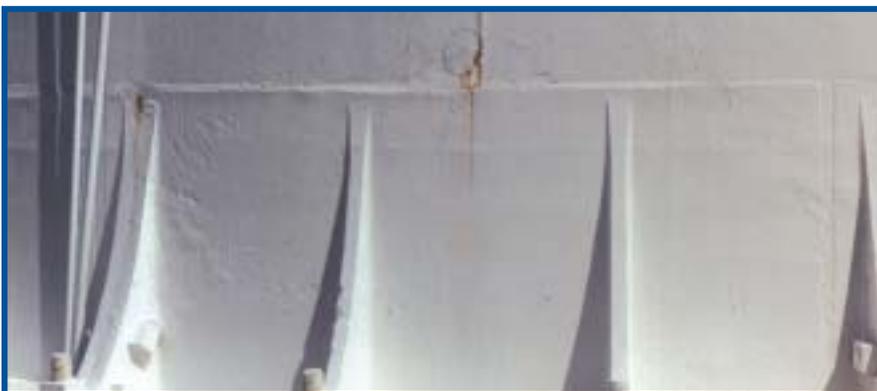
The Hunting Island Lighthouse was recently inspected in March of 2002. Overall, the lighthouse is in excellent condition. Only a few small rust spots were observed on the entire structure. The lower white section has chalked considerably, while the upper black section is doing very well with high gloss and no chalking. A small amount of mildew has once again started to

One of the few corrosion spots observed on lighthouse in 2002. This spot occurred at one of the plate seams.

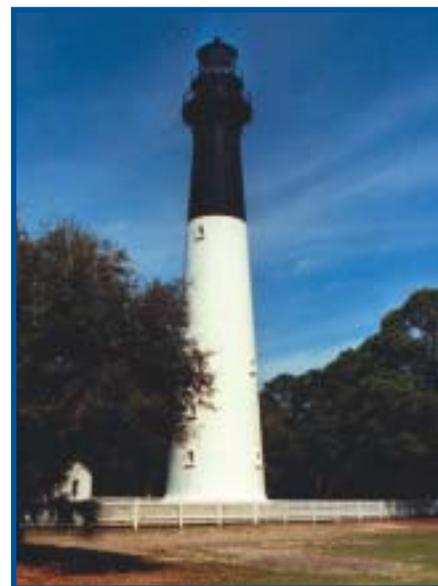
grow on the northwest side, but could probably be easily remedied with a bleach cleaning and pressure washing. Today, after twenty years of service, waterborne acrylic coatings are still protecting the Hunting Island Lighthouse from the elements, and provide an aesthetically pleasing exterior for the more than 1 million annual visitors to the Hunting Island State Park. After 127 years, this historic landmark deserves nothing less.

Lighthouse in March of 2002.
