WATERBORNE ACRYLIC RESINS FOR PROTECTIVE COATINGS

CASE HISTORY:

Sulfuric Acid Storage Tank

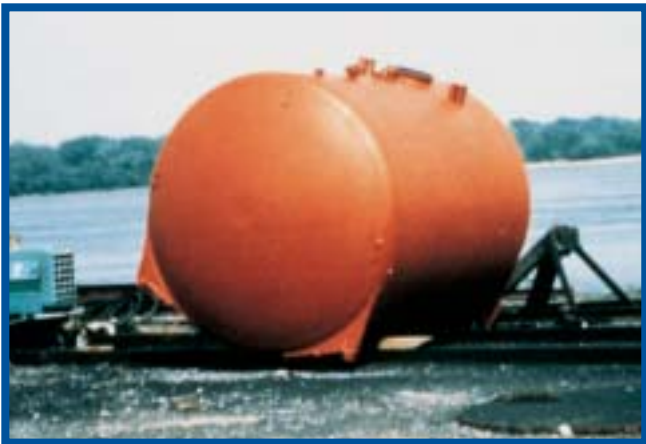
Tank after primer application.

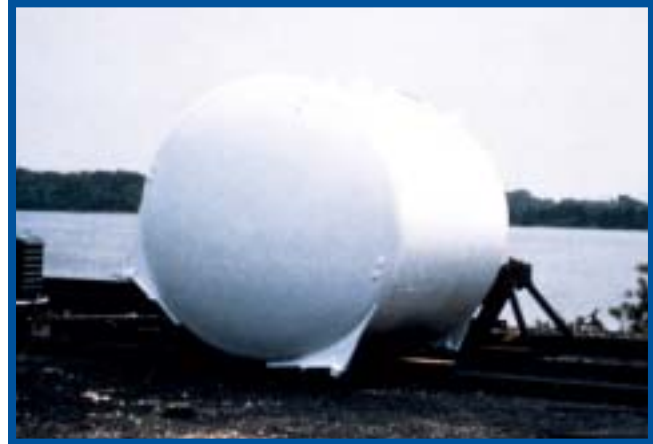
Tank after topcoat application.

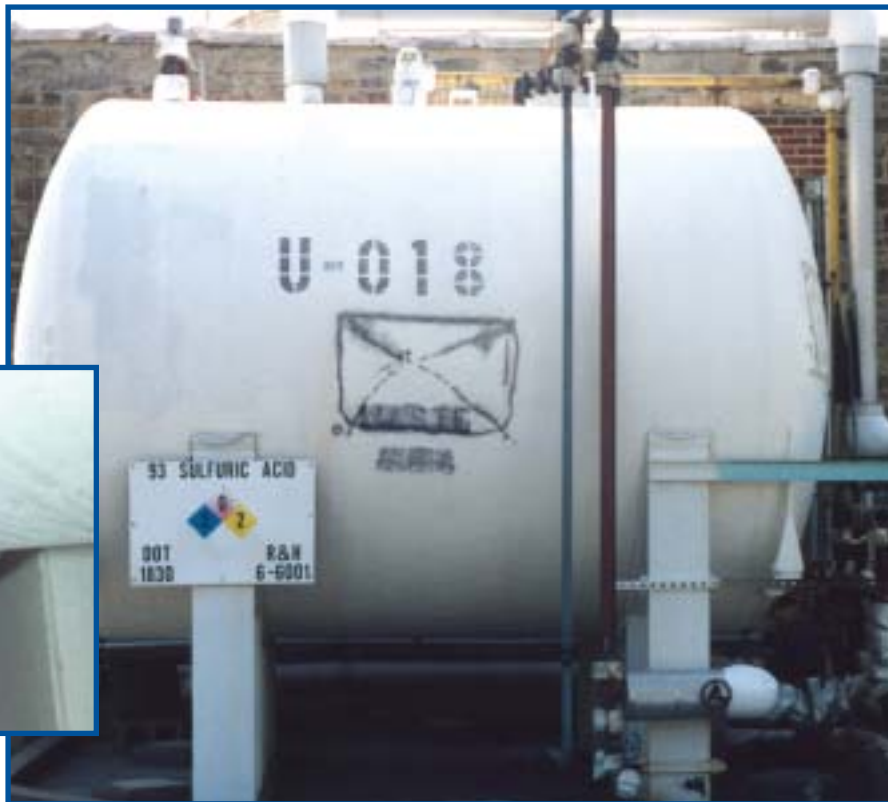
A recent examination of the tank after 17 years shows no signs of corrosion, except for one small spot of rust staining at one of the weld seams. Although the topcoat has chalked after 17 years, the waterborne acrylic coating is performing exceptionally well and is still protecting the tank from corrosion.

Tank after 17 years – August 2001.

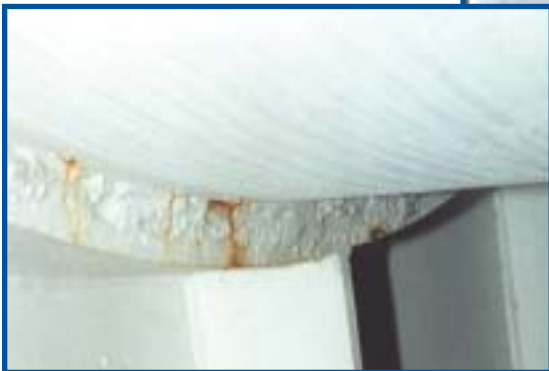
Small rust spots along weld seam on tank bottom – August 2001.
