WATERBORNE ACRYLIC RESINS FOR PROTECTIVE COATINGS

## CASE HISTORY: Calcium Hydroxide Slurry Tanks

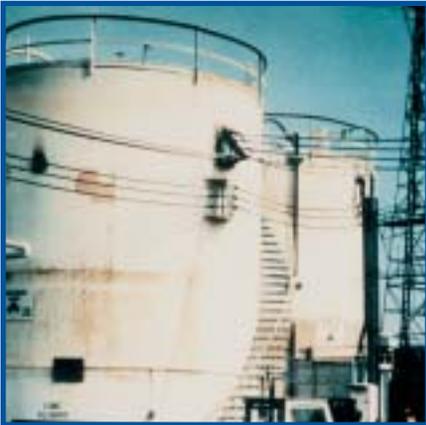
Tanks prior to painting in 1986.

These tanks needed repainting in 1986, because at that point the old thermoset paint system was flaking off. In addition to the normal weather patterns, the lime storage tanks are also subjected to a 200°F exotherm several times a week when dry lime is slaked into the tank mixture, a condition which would be expected to stress any paint system. Often because of viscosity restraints, solventborne coatings start out at relatively low

Sandblasting down to original shop primer.

2 coats of semi-gloss WB acrylic topcoat based on waterborne acrylic resin.

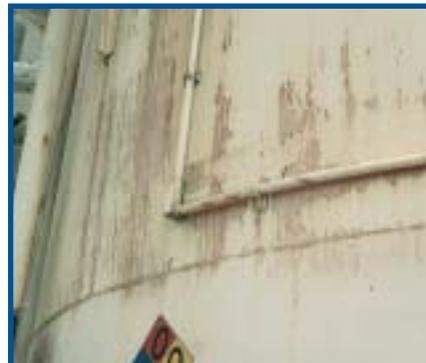
molecular weight and rely on crosslinking reactions after application to develop film toughness. However, these crosslinking reactions can often lead to a brittle film, which most likely led to the poor exterior performance of the original coating on these tanks. Waterborne acrylic latex paints have inherent toughness and excellent weathering properties due to the initially high molecular weight of the resins.

Close-up of tank showing flaking of the original thermoset coating.

In 1986, the tanks were sandblasted back to the original primer, and two coats of a waterborne acrylic latex paint replaced the original thermoset systems. On a recent inspection after 15 years of service, the tanks were still in excellent condition. The topcoat has chalked, but no significant signs of corrosion were found.

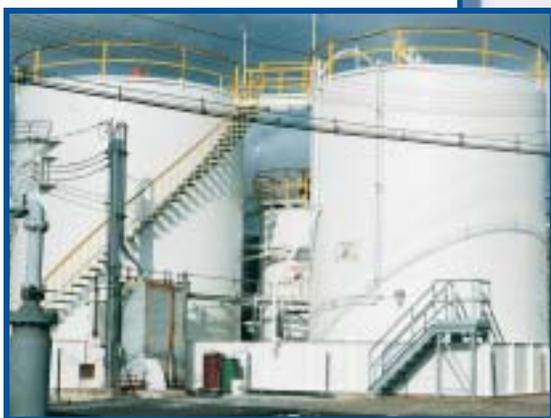
Tanks after painting in 1986.

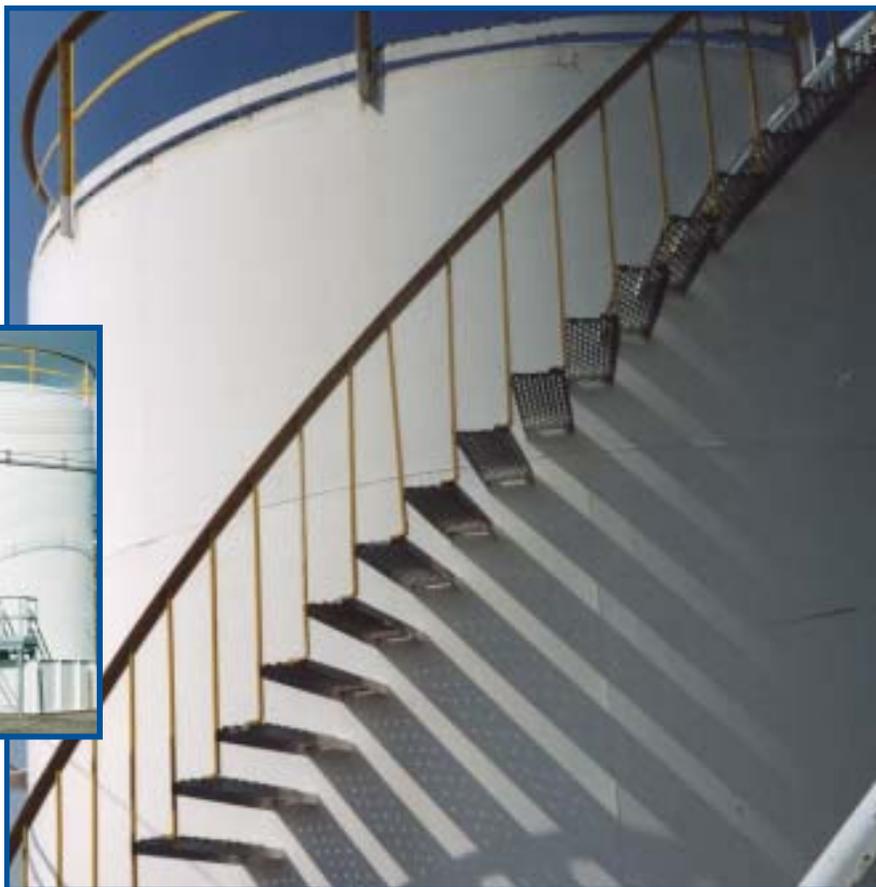
One of the tanks after 15 years - August 2001.
