## CASE HISTORY:

### Historic Lighthouse on Hunting Island, South Carolina

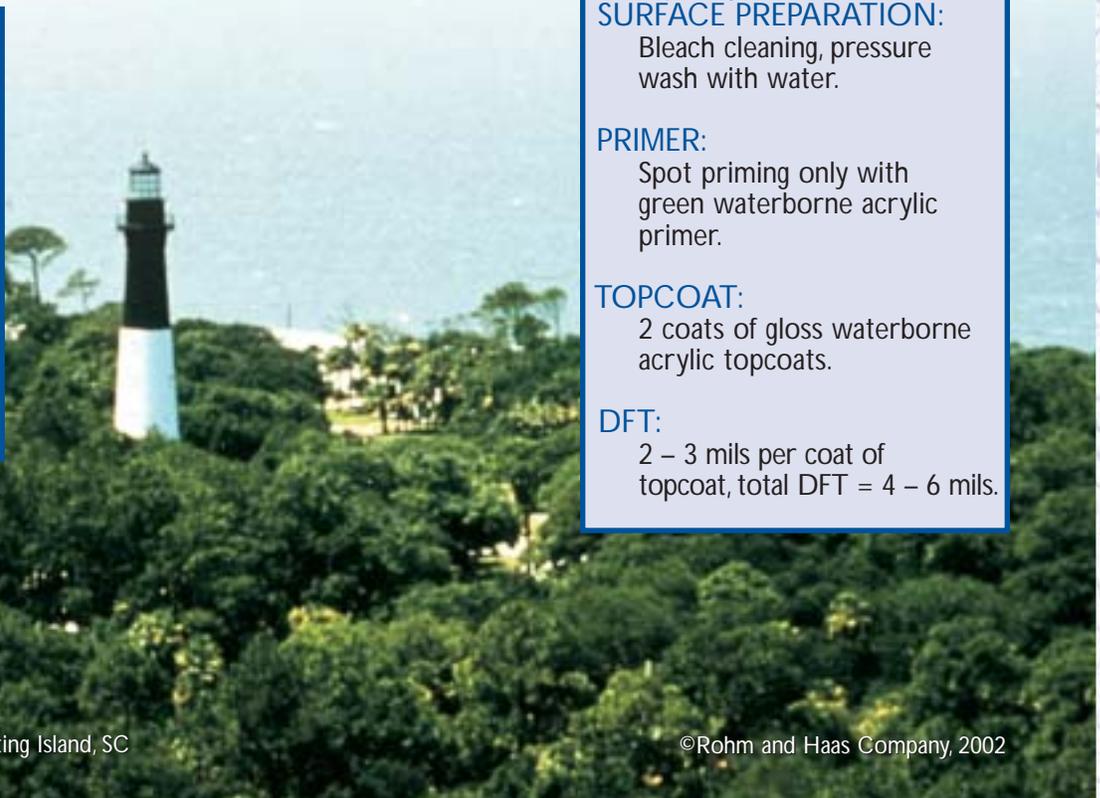
In 1981, a Rohm and Haas employee was vacationing on Hunting Island and noticed that the lighthouse was in bad disrepair. There were holes in the cast iron ranging in size from 1/4 to 2 inches in diameter. The alkyd coating that was applied seven years prior had deteriorated badly, embrittling and cracking, especially along the north side. Heavy rust spotting and run-down originating at the plate joints and the pitted areas had turned the once-attractive landmark into an eyesore. A complete restoration was planned.

Lighthouse in 1982 prior to restoration, showing heavy corrosion on northwest side

The first step in the 1982 restoration was to sandblast the cast iron plates back to bare metal. Thousands of holes were laboriously hand-filled using putty knives and an acrylic-modified cementitious compound which was designed to expand and contract with the metal. A red waterborne acrylic primer containing anti-corrosive pigments was applied to the clean steel, and followed by a white midcoat based on the same
