WATERBORNE ACRYLIC RESINS FOR PROTECTIVE COATINGS

CASE HISTORY:

Sulfuric Acid Storage Tank

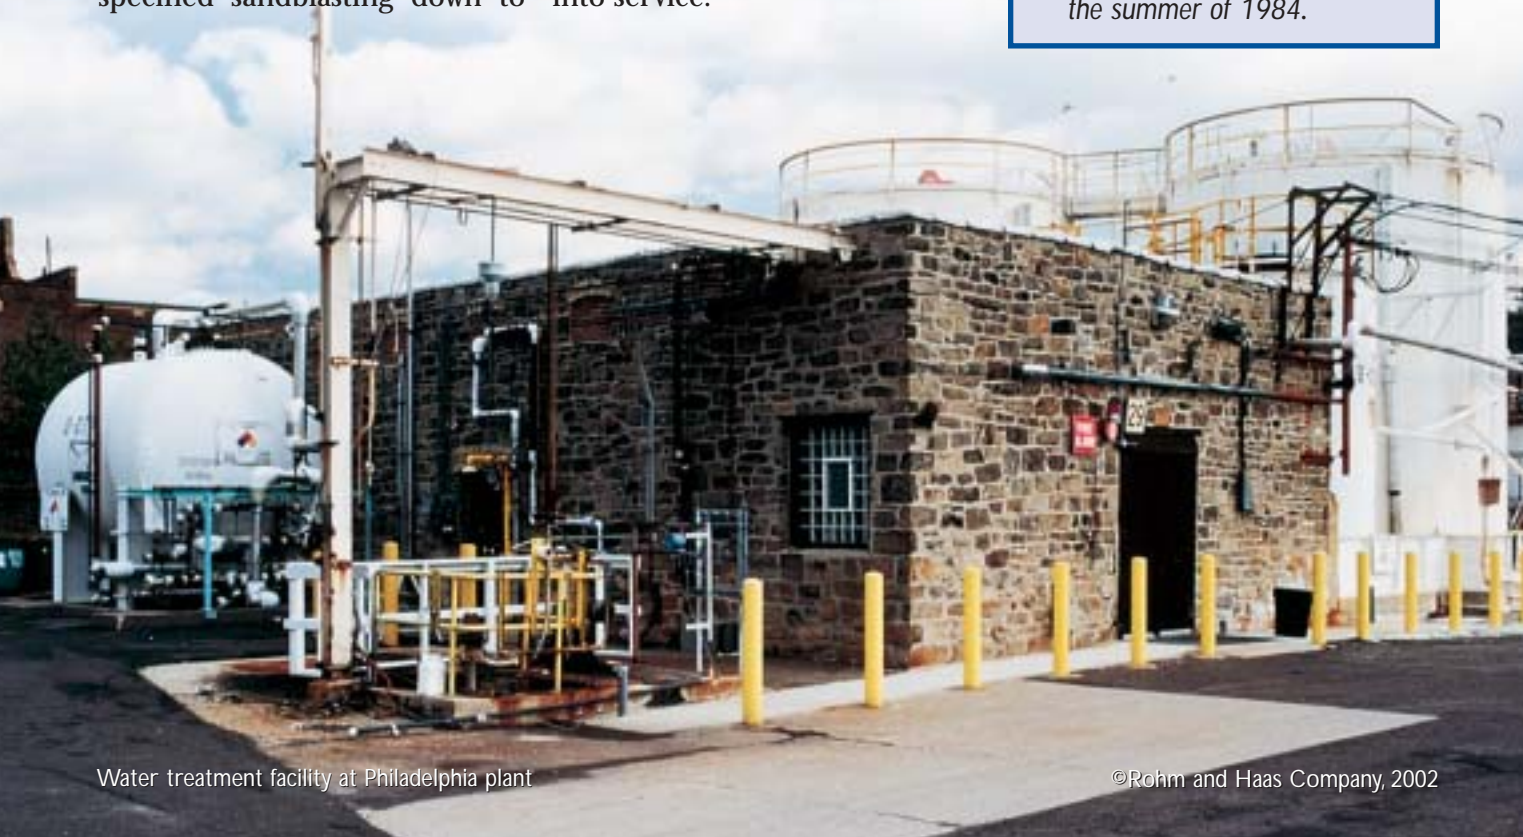
A recent examination of the tank after 17 years shows no signs of corrosion, except for one small spot of rust staining at one of the weld seams. Although the topcoat has chalked after 17 years, the waterborne acrylic coating is performing exceptionally well and is still protecting the tank from corrosion.
